# At Dolphin Stadium, No-Water Urinals Withstand Heavy Use and Abuse

**Require less maintenance than flushable counterparts**

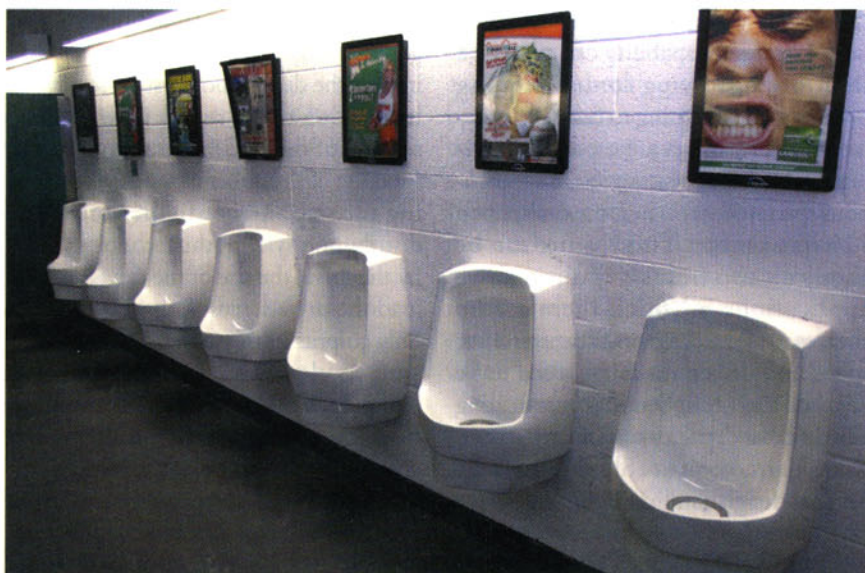
**Falcon Waterfree urinals inside Dolphin Stadium.**

At Dolphin Stadium, each no-water urinal requires only a few minutes of service per year.

The key to a no-water urinal is a biodegradable liquid sealant that floats on top of fluids, essentially trapping any odor from the depths of the unit. The sealant is contained in a replaceable cartridge installed at the bottom of the urinal in a fitting connected to a drainpipe. The cartridge, which typically lasts for about 7,000 uses, can be replaced in only a few minutes. The urinal requires no additional maintenance, other than being wiped down regularly with a recommended cleaner.
